Terra Cotta Repair

New method developed by Kolbjorn Saether

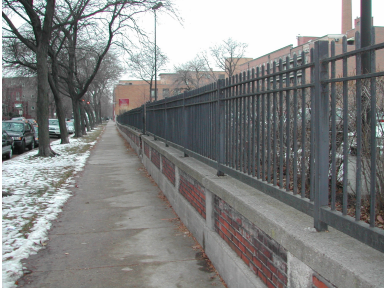
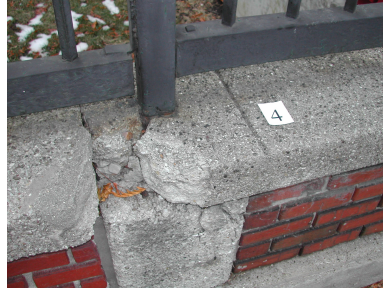
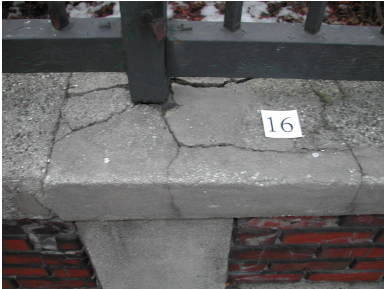
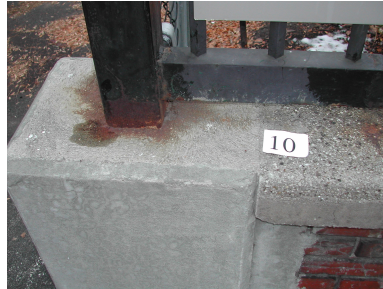
How could mistakes like this happen? We even see cases of this happening right in our time. An example is a fence around St. Mary's Hospital in Chicago. Out of some 30 steel posts, 16 had caused the supporting concrete caps to crack. Number 10 was so bad; the concrete base had been replaced.

This cracking was due to expansion of the steel. As corrosion occurs, the effected steel layer will increase in size 6 to 8 times. As in the post/concrete top plate case, inside a terra cotta unit, if a pin is located next to or within a terra cotta unit rib, this increase can cause the unit to crack. One advantage for this type of damage, however, is that it is visible and can be identified and repaired. (One of today's accepted repair methods is the use of stainless steel pins. For this method, holes are drilled into the terra cotta unit through which pins are installed. This method, however, does not do the whole job as the corrosion of the steel within the unit is allowed to continue to corrode.)

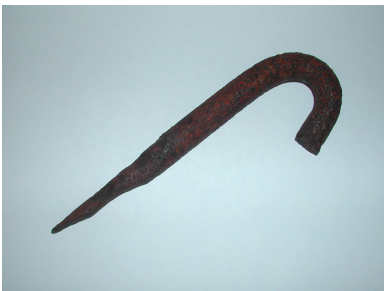
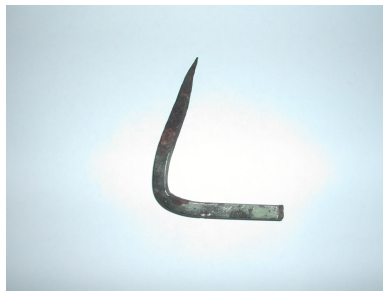
That this corrosion actually takes place is no myth (see pictures above). The first sample is a 5/8" Ø J-bolt, which has been reduced to zero due to corrosion. The same is the case with the second example, the 1/4" x 1/4" tie. Again, the section is reduced to zero.

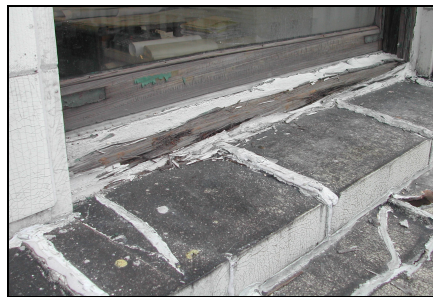
Cracked terra cotta windowsill.

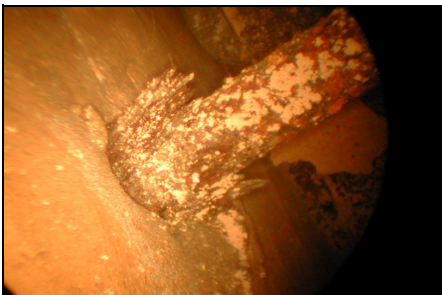
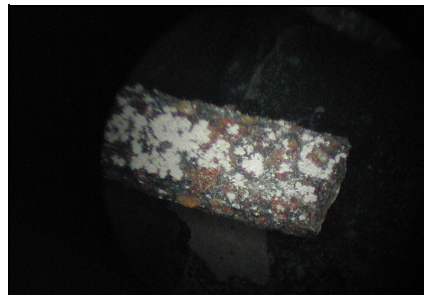
Slivers of corroded metal inside a rib.

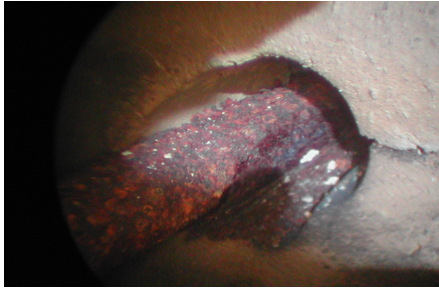
Corroded pin.

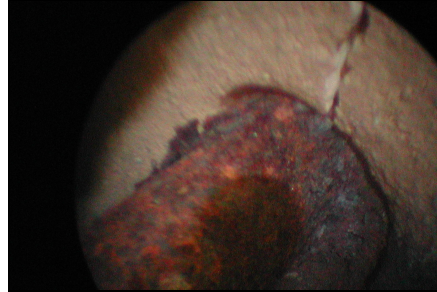
Cracked rib.

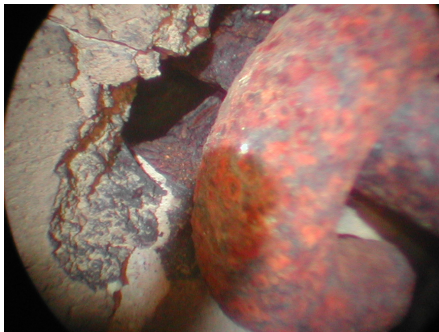
Corroded pin and cracked rib.

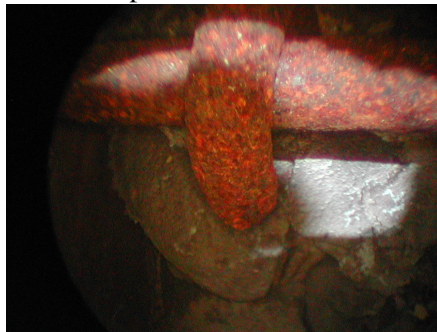
J-bolt and pin intersection.
