# **A Novel Method for Terra Cotta Repair**

by Kolbjorn Saether

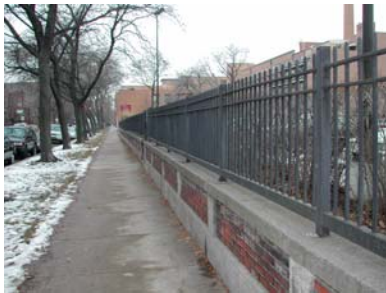
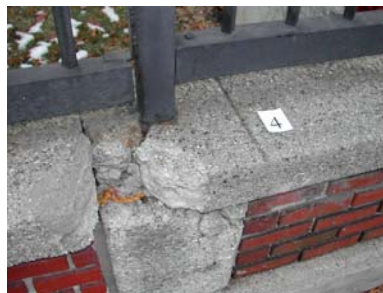
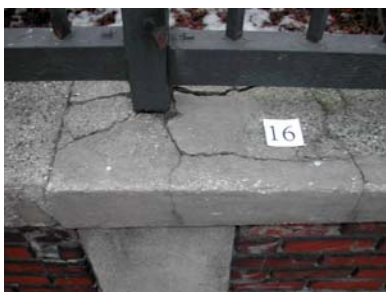
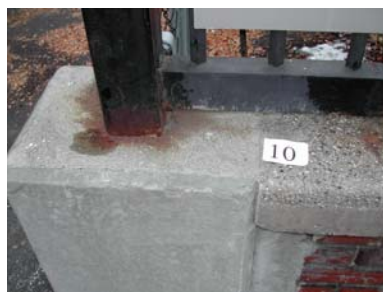
How could mistakes like this happen? We even see cases of this happening right in our time. An example is a fence around St. Mary's Hospital in Chicago. Out of some 30 steel posts, 16 had caused the supporting concrete caps to crack. Number 10 was so bad; the concrete base had been replaced.

This cracking was due to expansion of the steel. As corrosion occurs, the effected steel layer will increase in size 6 to 8 times. As in the post/concrete top plate case, inside a terra cotta unit, if a pin is located next to or within a terra cotta unit rib, this increase can cause the unit to crack. One advantage for this type of damage, however, is that it is visible and can be identified and repaired. (One of today's accepted repair methods is the use of stainless steel pins. For this method, holes are drilled into the terra cotta unit through which pins are installed. This method, however, does not do the whole job as the corrosion of the steel within the unit is allowed to continue to corrode.)

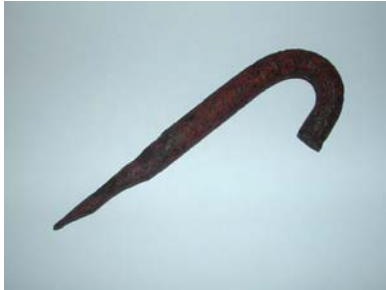
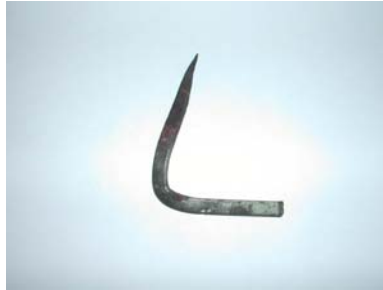
That this corrosion actually takes place is no myth (see pictures above). The first sample is a 5/8" Ø J-bolt, which has been reduced to zero due to corrosion. The same is the case with the second example, the 1/4" x 1/4" tie. Again, the section is reduced to zero.

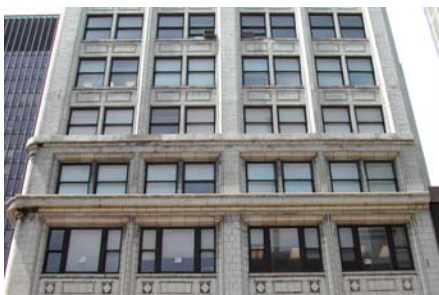
220 South State Street.

The building façades at 220 South State Street in Chicago were inspected using this scope. Except for some relatively small cracks, initially, no dramatic damage was observed from the ground or from the swing stage. When looked at with the fiber optic scope, however, the situation showed up quite differently. Corroded pins were found throughout. Slivers of corroded metal trapped in the terra cotta ribs could be seen. This then resulted in cracks through the rib and terra cotta facing.

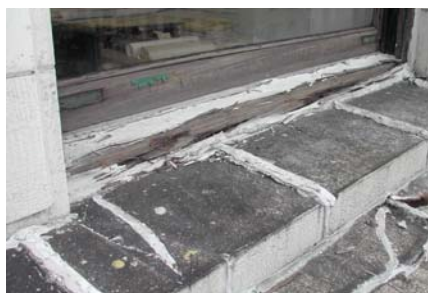
Cracked terra cotta windowsill.

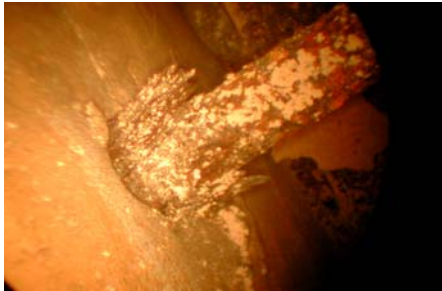
Slivers of corroded metal inside a rib.

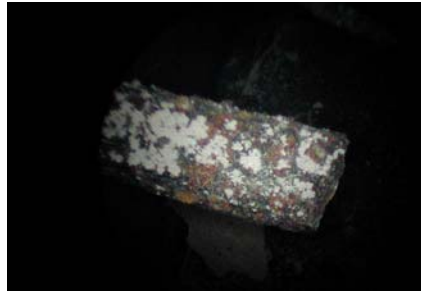
Corroded pin.

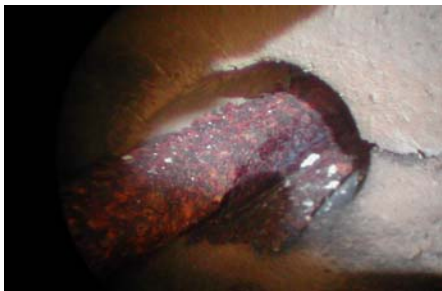
Cracked rib.

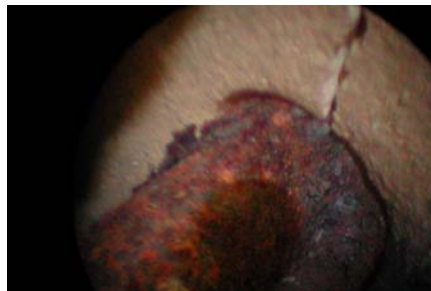
Corroded pin and cracked rib.
