Terra Cotta Repair

New method developed by Kolbjorn Saether

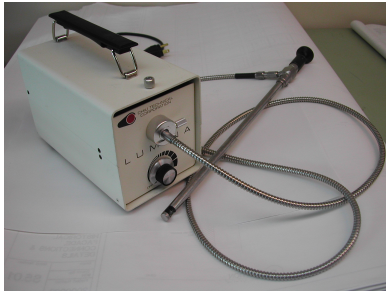
To avoid the expense of physically opening the unit for inspection, and then repairing and or replacing the unit, a cost effective and foolproof method for identifying the damage is the use of a fiber optic scope. This inspection method is minimally invasive requiring only a small hole on the order of 1/4" Ø to 1/2" Ø to be drilled into the unit.

The fiber optic scope is a simple instrument. It has an eyepiece on top to which a camera can easily be mounted. It can look straight down or, with a mirror attachment; the view can be bend 90° and rotated to give a 360° view of the cavity.

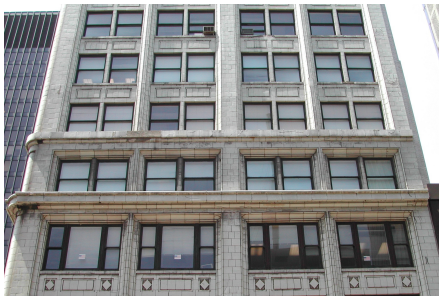
220 South State Street.

The building façades at 220 South State Street in Chicago were inspected using this scope. Except for some relatively small cracks, initially, no dramatic damage was observed from the ground or from the swing stage. When looked at with the fiber optic scope, however, the situation showed up quite differently. Corroded pins were found throughout. Slivers of corroded metal trapped in the terra cotta ribs could be seen. This then resulted in cracks through the rib and terra cotta facing.
