# **A Novel Method for Terra Cotta Repair**

by Kolbjorn Saether

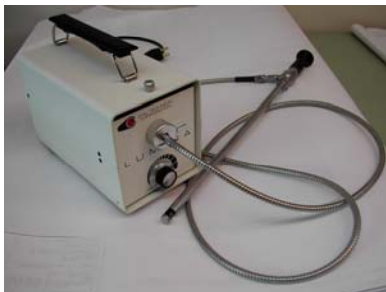
To avoid the expense of physically opening the unit for inspection, and then repairing and or replacing the unit, a cost effective and foolproof method for identifying the damage is the use of a fiber optic scope. This inspection method is minimally invasive requiring only a small hole on the order of 1/4" Ø to 1/2" Ø to be drilled into the unit.

The fiber optic scope is a simple instrument. It has an eyepiece on top to which a camera can easily be mounted. It can look straight down or, with a mirror attachment; the view can be bend 90° and rotated to give a 360° view of the cavity.

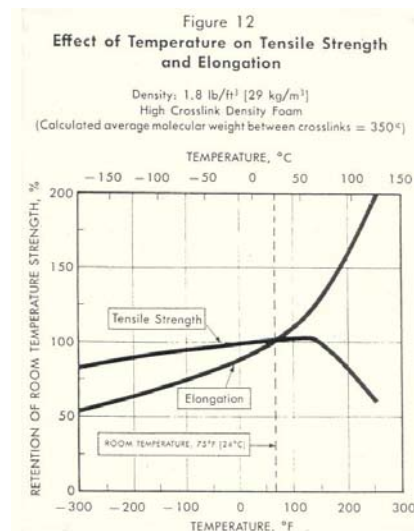
In search of an answer, the surprise solution was that all three could be obtained from a system and a material used for something entirely different. Polyurethane Foam had been used for years to seal cracks in rocks and concrete. This foam would stick to almost everything. It was waterproof, but it had a tensile strength of only 10 to 60 psi. However, when multiplied with 200 in<sup>2</sup>, this would make a force of 2000 to 12000 lbs. A large terra cotta unit could weigh 333 lbs. A typical unit would generally have two or three open cells, approximately 5" x 14" = 70" each. When multiplied with 3, the three units would have a total area of 210 in<sup>2</sup>. This times 5 psi results in 1000 lbs. If made to carry the unit in tension this alone would mean a safety factor of 3 to 1.

To hold a two-inch thick piece of terra cotta, with full foam back up, only 0.15 psi would suffice.

In other words, these repairs could be done with polyurethane foam. This material having the consistency of maple syrup could be injected through a ¼" Ø hole as a liquid, expanded 10 to 20 times its original volume, squeezed into every crack and crevice and void, allowing the excess foam to be squeezed out of the inlet hole and then, once cured after approximately 15 minutes, bonding itself to the inside of the terra cotta unit. It would hold any cracked and loose pieces in a firm grip and would stick to the backup masonry wall with a force 3 times or more than the weight of the unit itself. It would surround any exposed steel and encapsulate and rustproof this steel preventing further corrosion. If there should be any water present in the cavity, the polyurethane, which is hydrophilic, would make use of this to develop the foam. Actually, for a successful application the installer would add given amounts of water. To recap: The foam encapsulates the steel. It protects this against corrosion. It solidifies broken terra cotta units. It fastens the units to the back-up wall. It dries up any moisture. It costs very little to buy, and it costs very little to apply.
